ST DROSTAN'S CHURCH, MARKINCH, FIFE

A Survey of Masons' Marks within the Tower

July 2015

Moira Greig

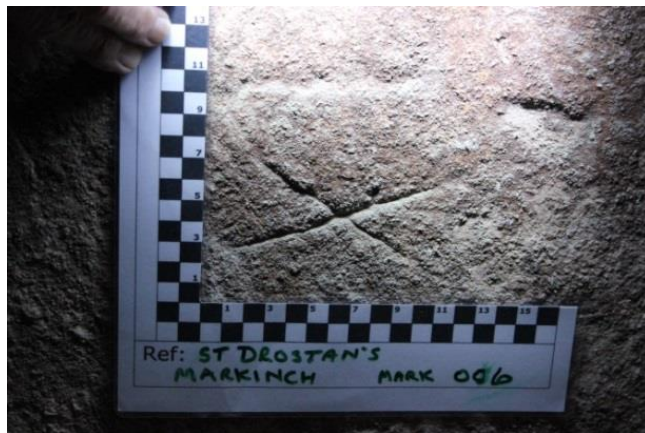
Mason 1 -Mark No 6

A simple saltire cross identified this Mason 1, who worked on all but the 4th floor. A total of 79 instances where his mark was identified are recorded. The mark was usually a fairly precise cut, although a number showed poor survival due to stone decay.

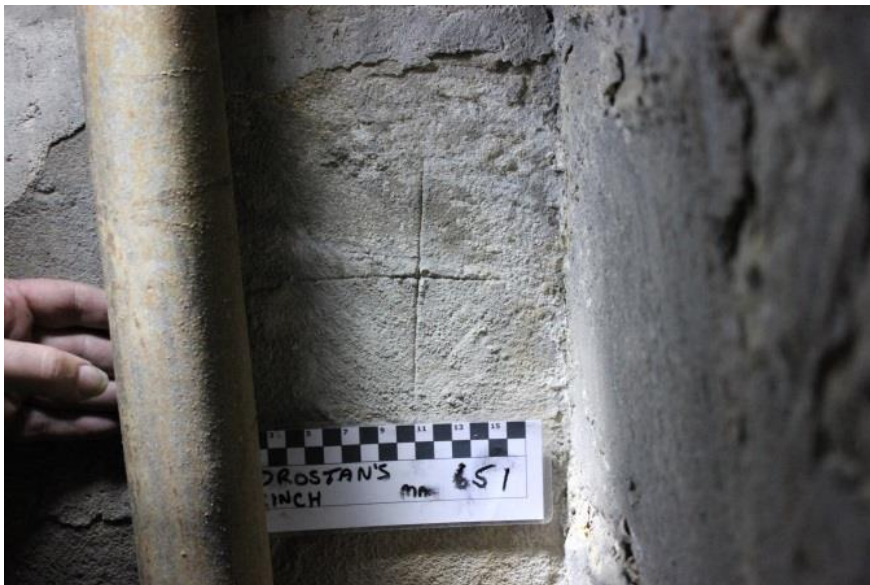
Mason 15 - Mark 651

This mason used a straight forward right-angled cross, although occasionally one leg could be slightly longer as shown in mark 534 below. This mason's mark was found on the ground floor, 1st, 2nd and 4th floor with a total of 18 instances being recorded.

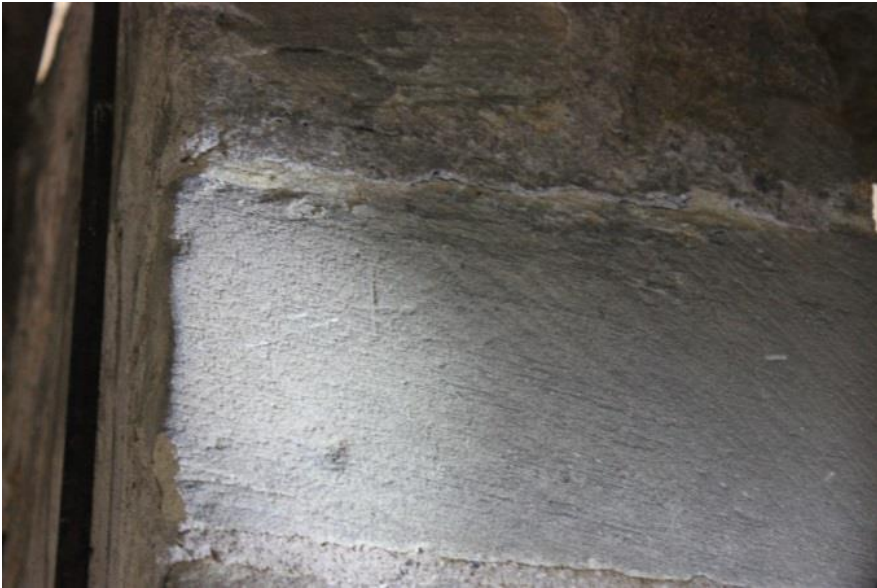
Mason 30 - Mark 567

This was a very precise small cross quite distinct from mason 15. He appeared only to work on the 2nd floor, as his mark was not noted anywhere else. Only 5 of his marks were recorded.

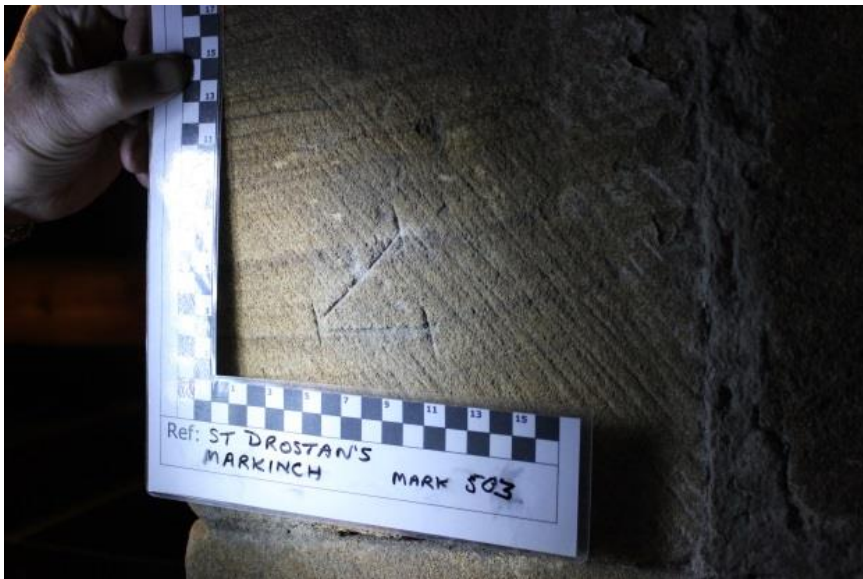
Mason 2 – Mark 503

A Roman 5 was used by this mason, who worked in all areas apart from the spiral stair. 64 of his marks were recorded. Occasionally some of the slashes on the legs or point could be longer than others.

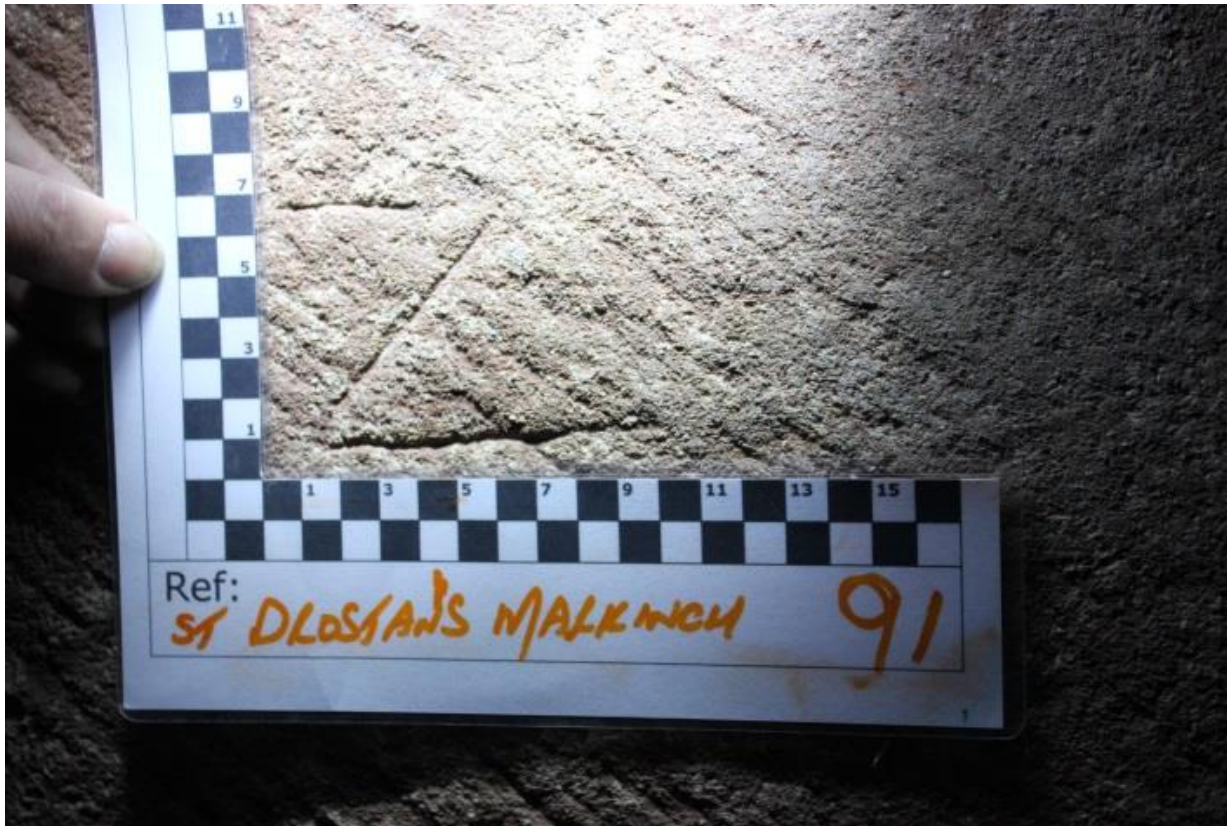
Mason 8- Mark 91

Very similar to Mason 4 is the mark of Mason 8, whose mark is in reverse of 4. He worked on the ground, 1st floor and 2nd floor. 16 of his marks were recorded.

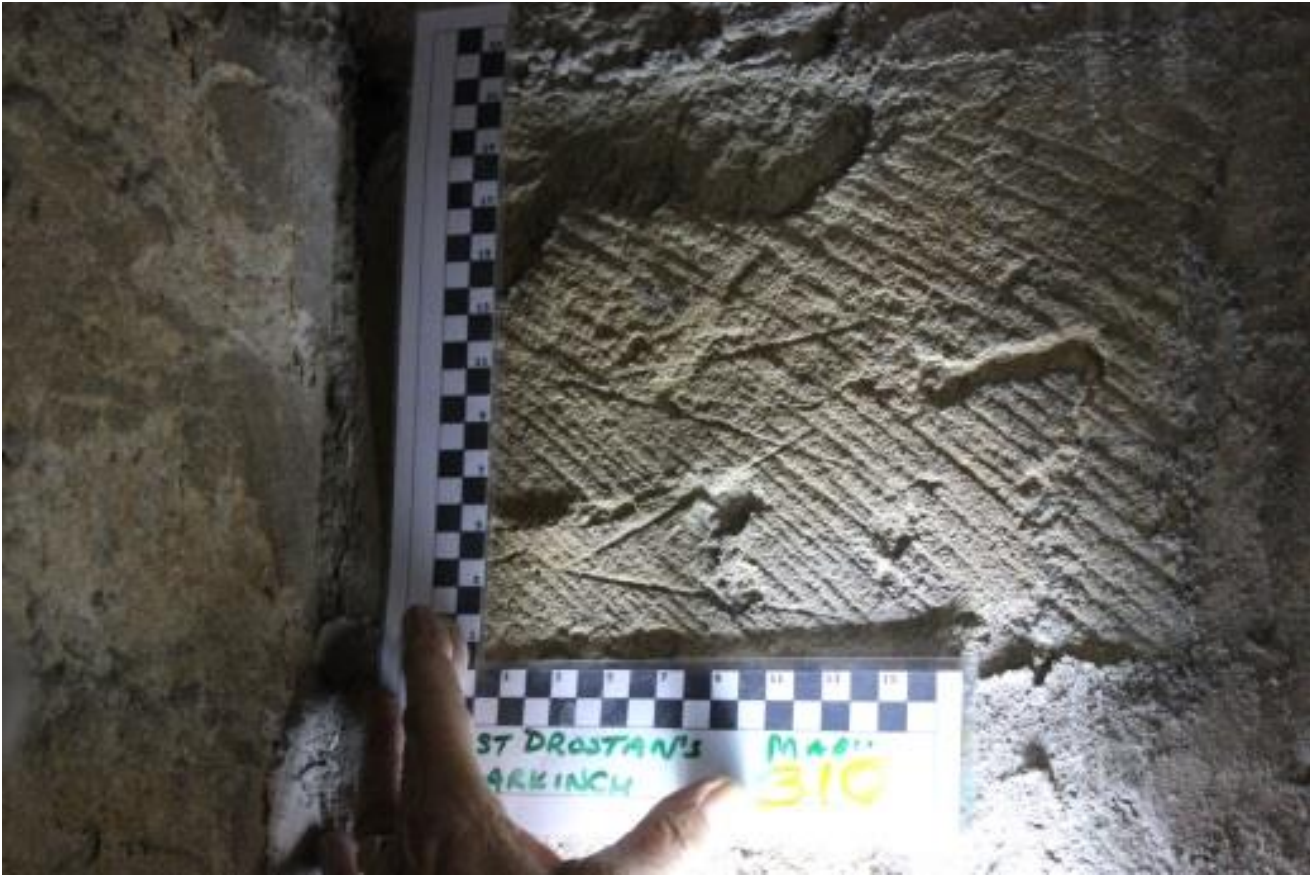
Mason 5 – Mark 310

Examples of damage by stone erosion or spalling of surface are shown on the two photos below.

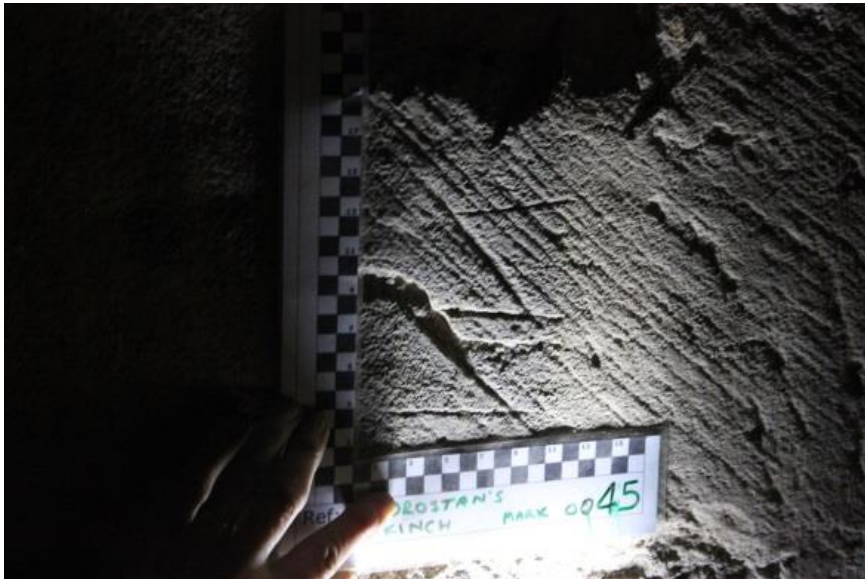
Mason 11 – Mark 45

A mark similar to Mason 5 was used by this mason but with an added leg. His mark was only recorded twice, once on the ground floor and the other on the spiral stair.

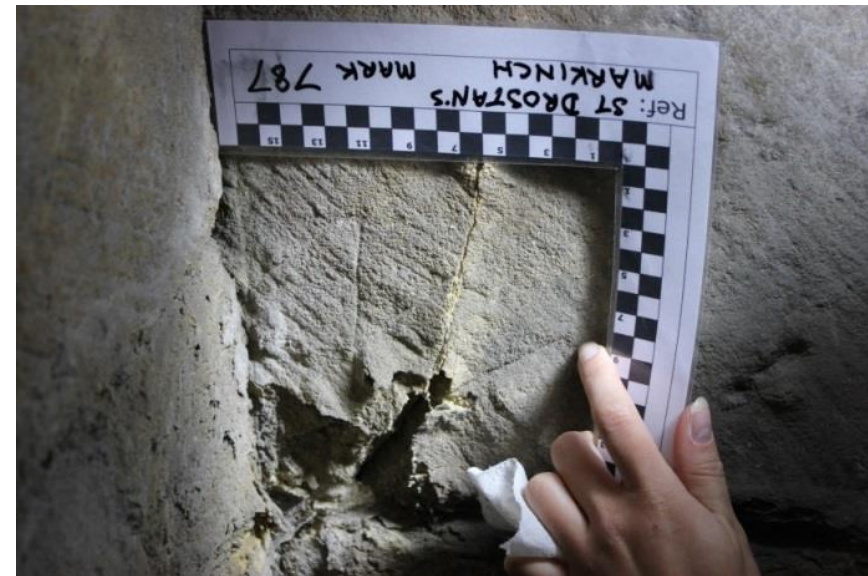
Mason 11 – Mark 787.

Both show severe spalling of the stone surface.

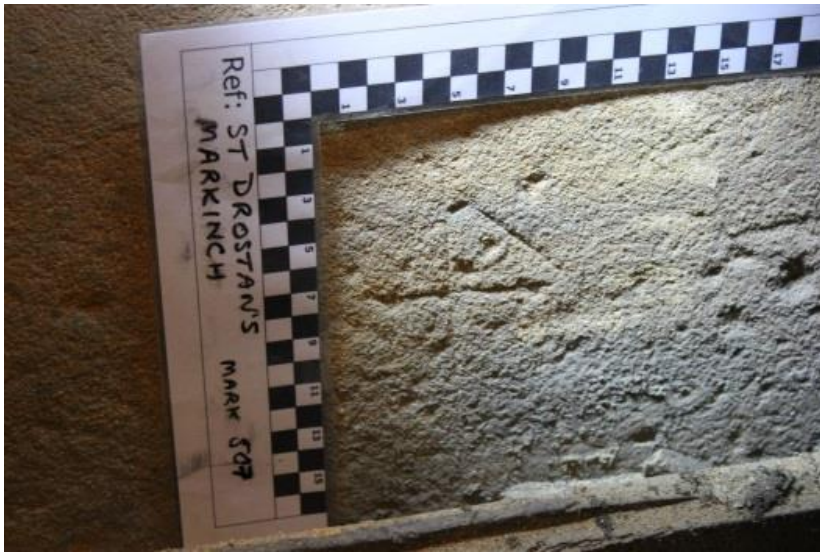
Mason 6 – Mark 507

A triangle with two extended legs, or a tepee-shaped mark, which could show variations occasionally, was this mason's mark. Mason 6 worked in all areas apart from the 4th floor. 69 of his marks were recorded.

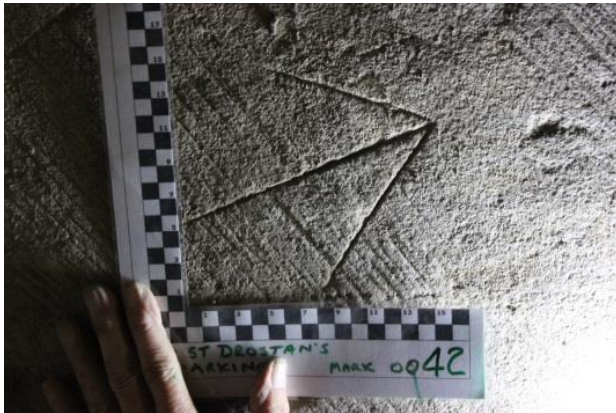
Mason 7 – Mark 42

The most prolific of all the masons, he used an arrow as his mark and again there are a number of variations which could indicate that he had others, such as an apprentice, mark his stone for him. He worked in all areas of the tower. 196 of his marks were recorded.

The mark of Mason 7 can similarly be placed at Arbroath Abbey with an early 14th century date and at Drum Castle where it is found on areas dating from the 13th century to the 14th century. It is also found again at Inverquhar Castle, which is dated to the 16th century. Indeed the marks of Masons 1, 15, 20, 29 and 30 can also be found at Arbroath Abbey, all in parts dating from the 13th-14th century.

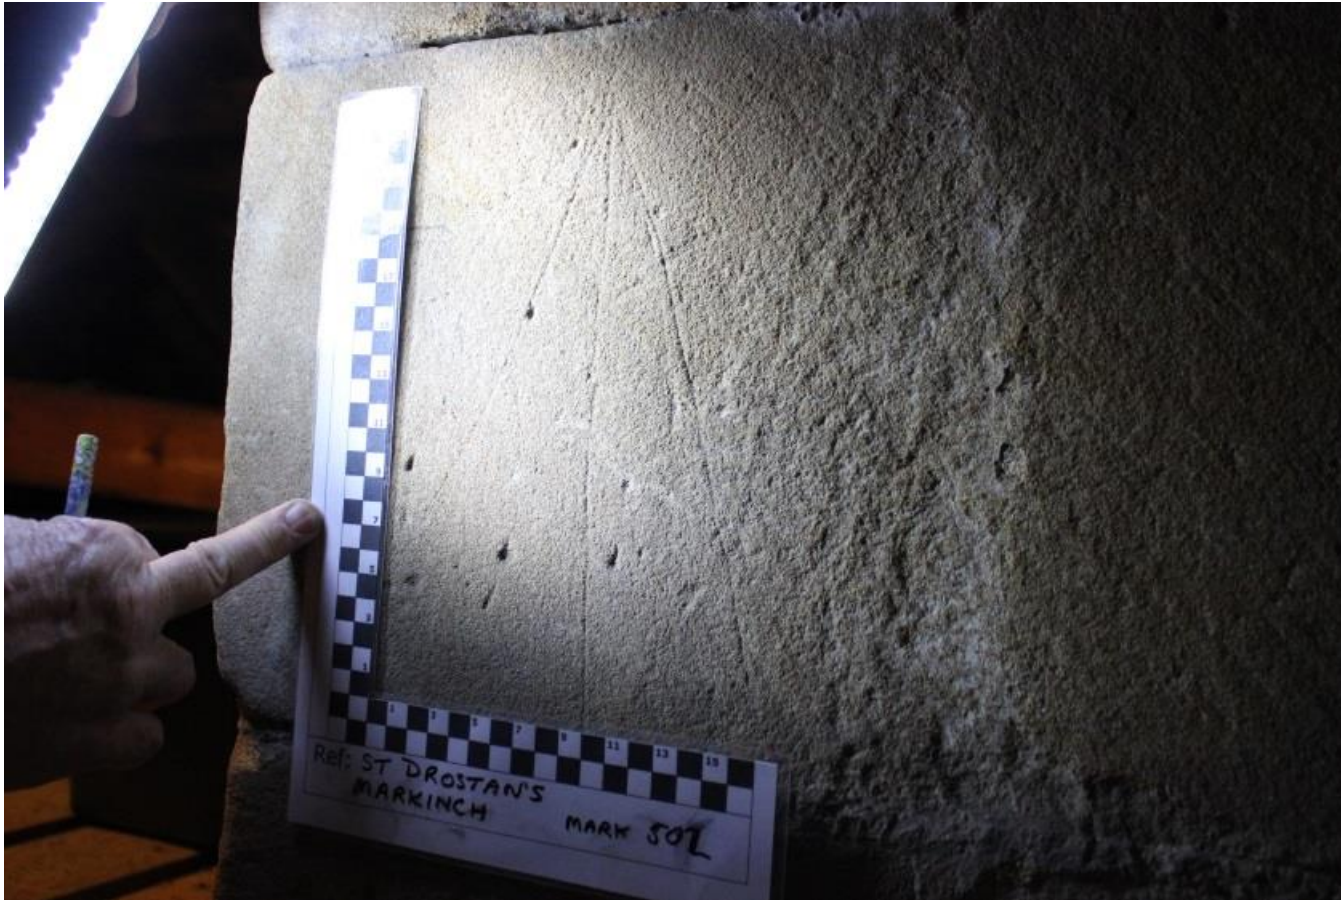
Mason 7? – Mark 502 This arrow was of a much larger scale than the others but only one example so probably is Mason 7.

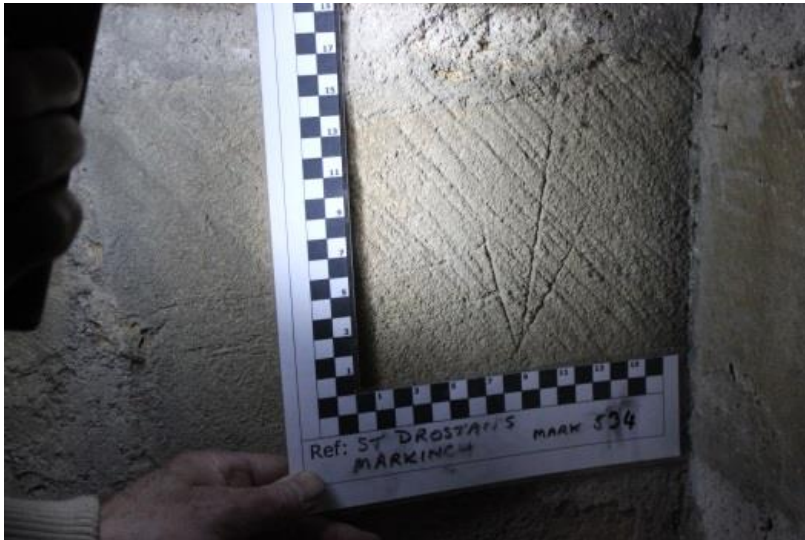
Mason 13 – Mark 534

A mark very similar to Mason 7 was made possibly by another mason. This mark, although also an arrow, is usually smaller and narrower in dimensions than Mason 7's mark. The tail is also usually longer so it is just possible this is a different mason. He worked on the ground floor, 1st, 2nd, 3rd floors and on the stairs. 17 marks were recorded.

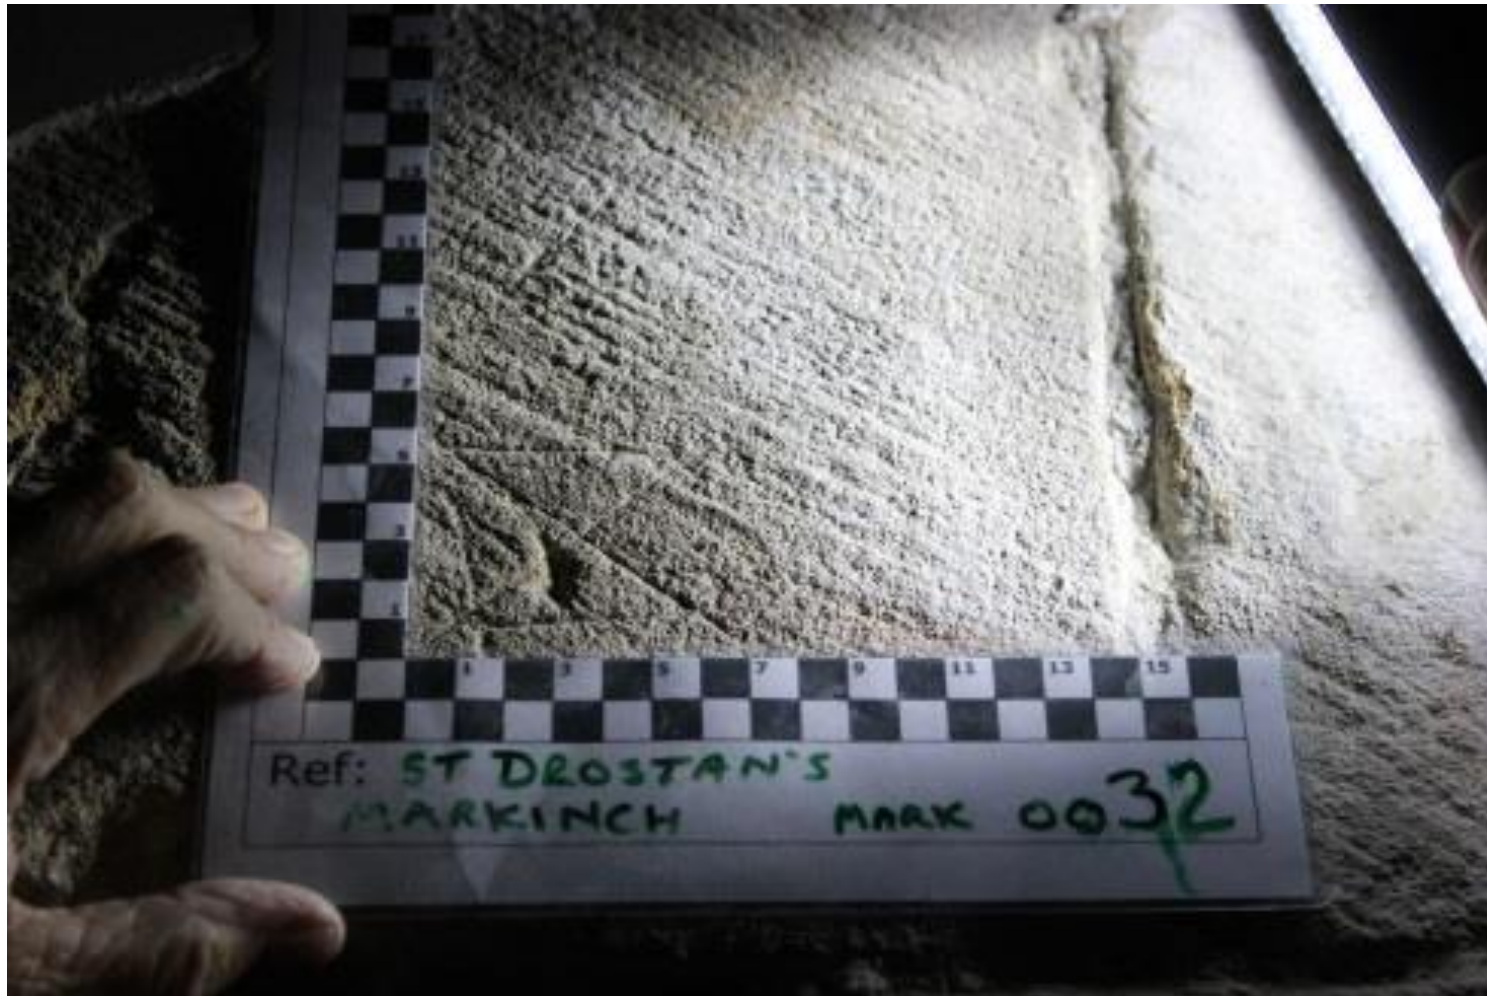
Mason 10 – Mark 32

A St Andrews cross filled in on three sides, or an hour glass with one side filled. This mason worked on the ground floor, 2nd floor and 3rd floor. Only five of his marks were recorded. This mason could be related to Mason 12 below.

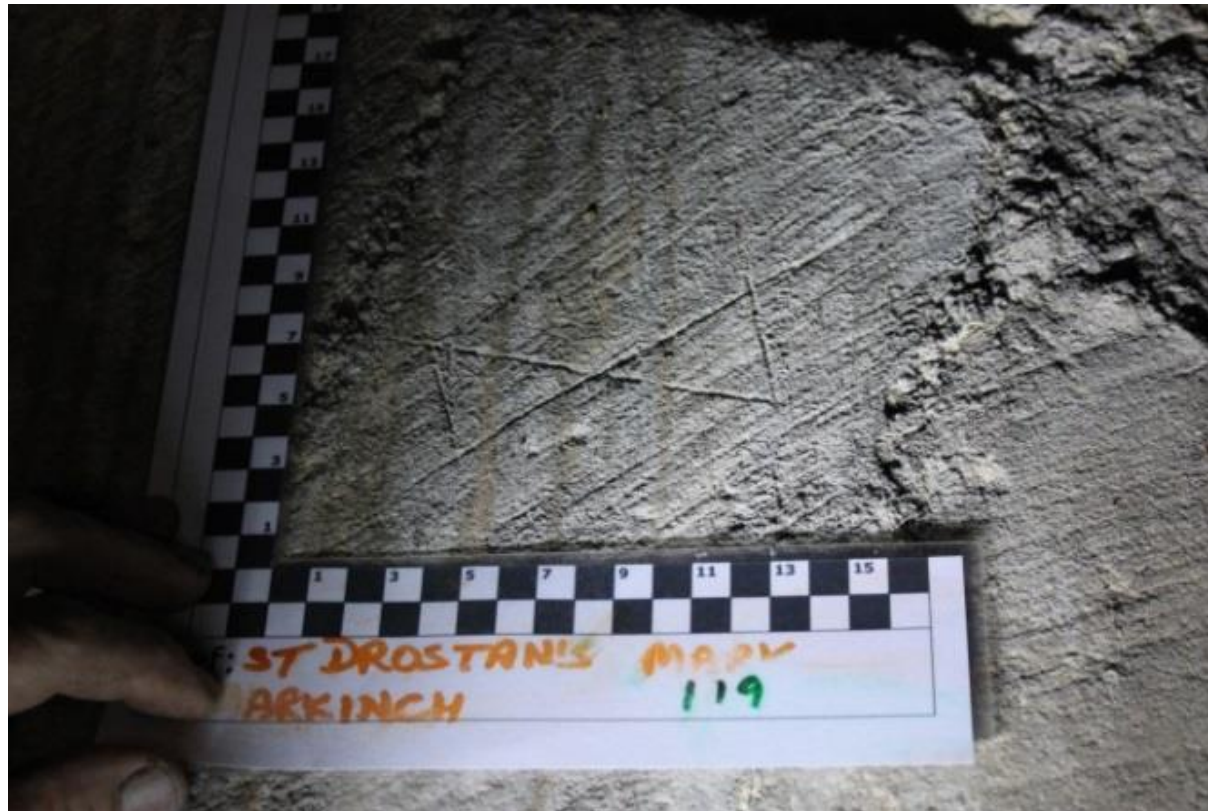
Mason 12- Mark 119

Another prolific mason, whose mark was recorded 106 times, is Mason 10. His mark is an 'egg timer' or double triangle. He worked in all areas apart from the 3rd floor, where his mark was not noted, although it could have been hidden by later beams. It is possible that he was the master mason, as there are two stones with his mark and other marks also on them. He cut his mark in a very precise way using his chisel marks as the basis for his first line. Note this on the two photos below.

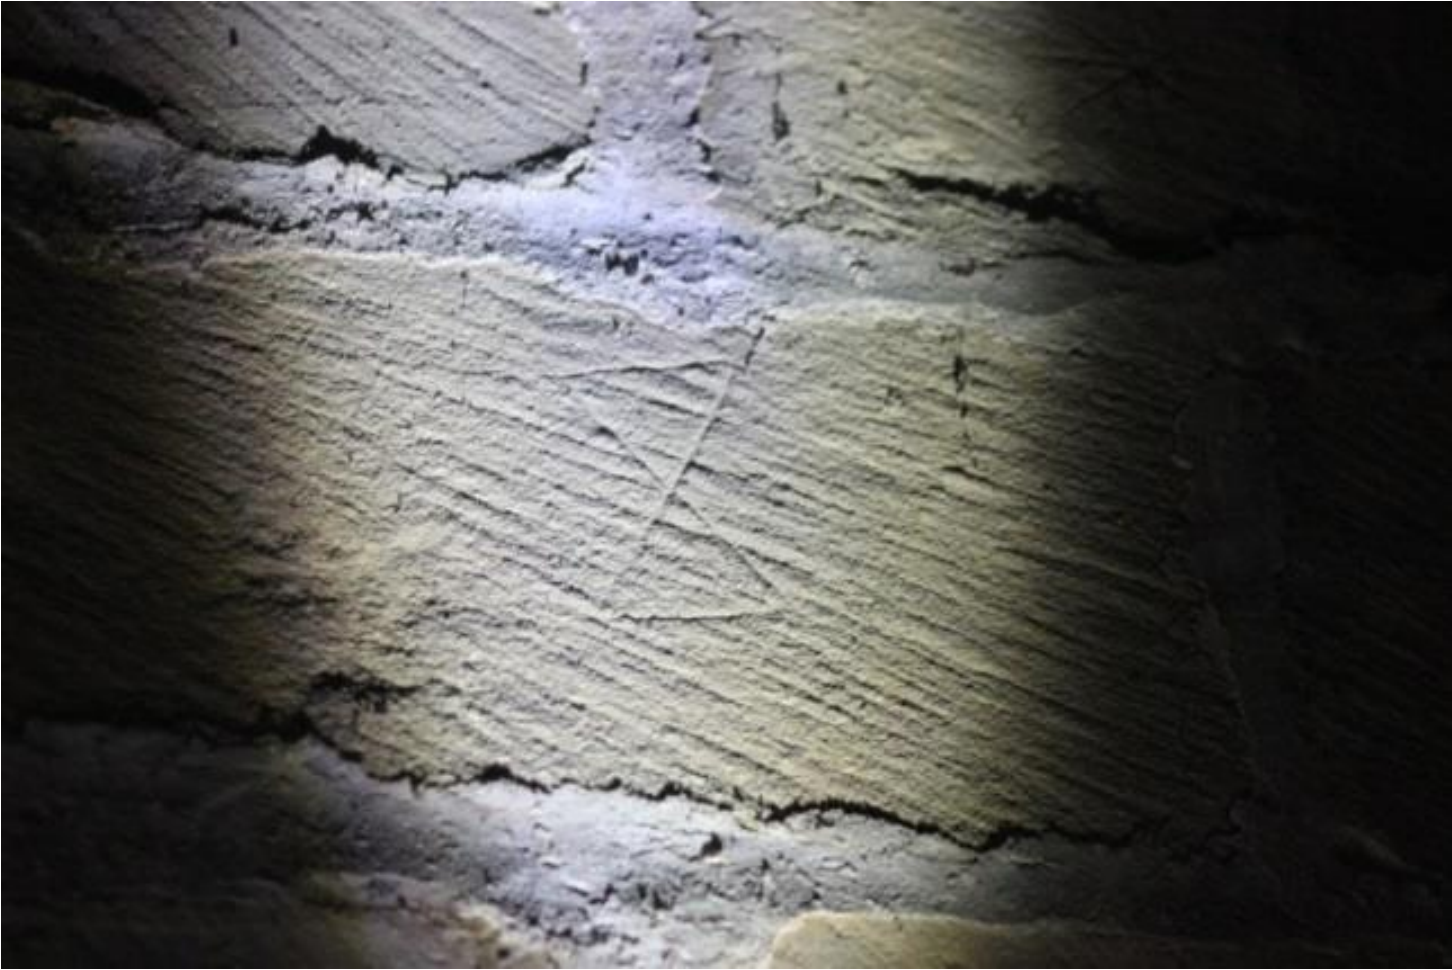
Mason 12 – Mark 423

These two marks below are not cut on the working chisel lines as usual so may have been marked by his apprentices.

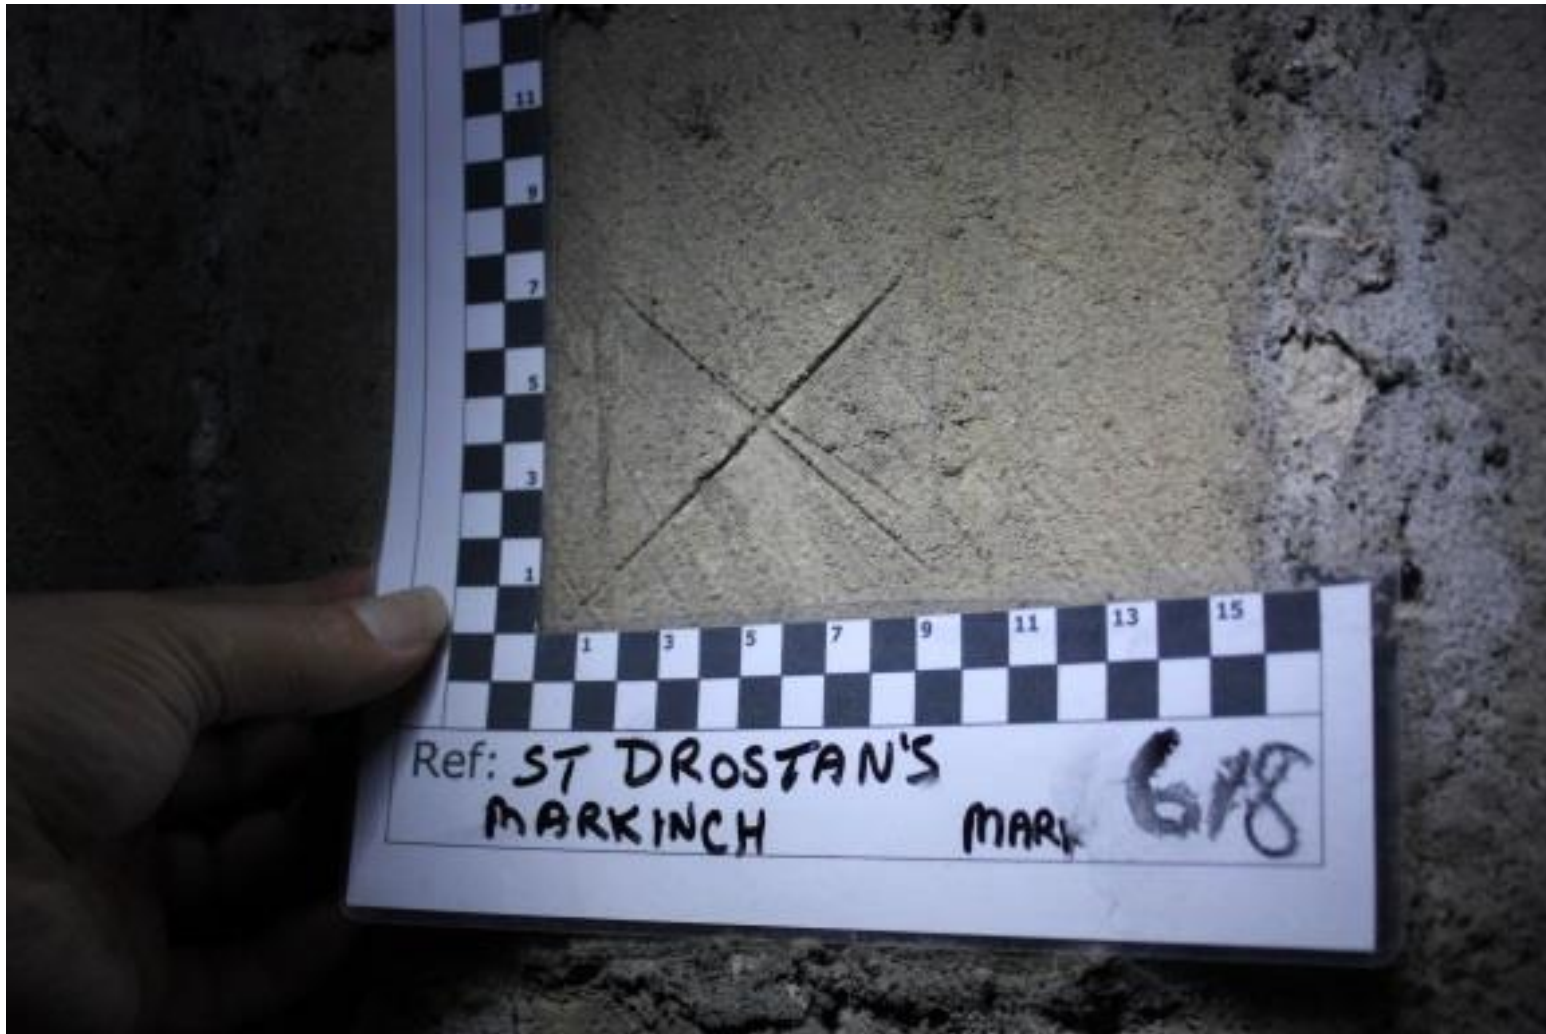
Mason 12 – Mark 618

The examples below show a mis-cut of one of the lines and an overcut.

Mason 12 is notable for the deliberate way he cut his mark into a finished block. It was very precise and made use of the lines of dressing across the face of the block for cutting of the diagonal line of his mark. There is also, I think, clear evidence that not all the marks allocated to him, were actually cut by him. In some cases the mark does not align with the way the stone was dressed, in particular marks 369 and 423. There are also some slight extensions to the cutting which over-run the general shape, as well as some obvious mis-cuts and then recut (mark 618).

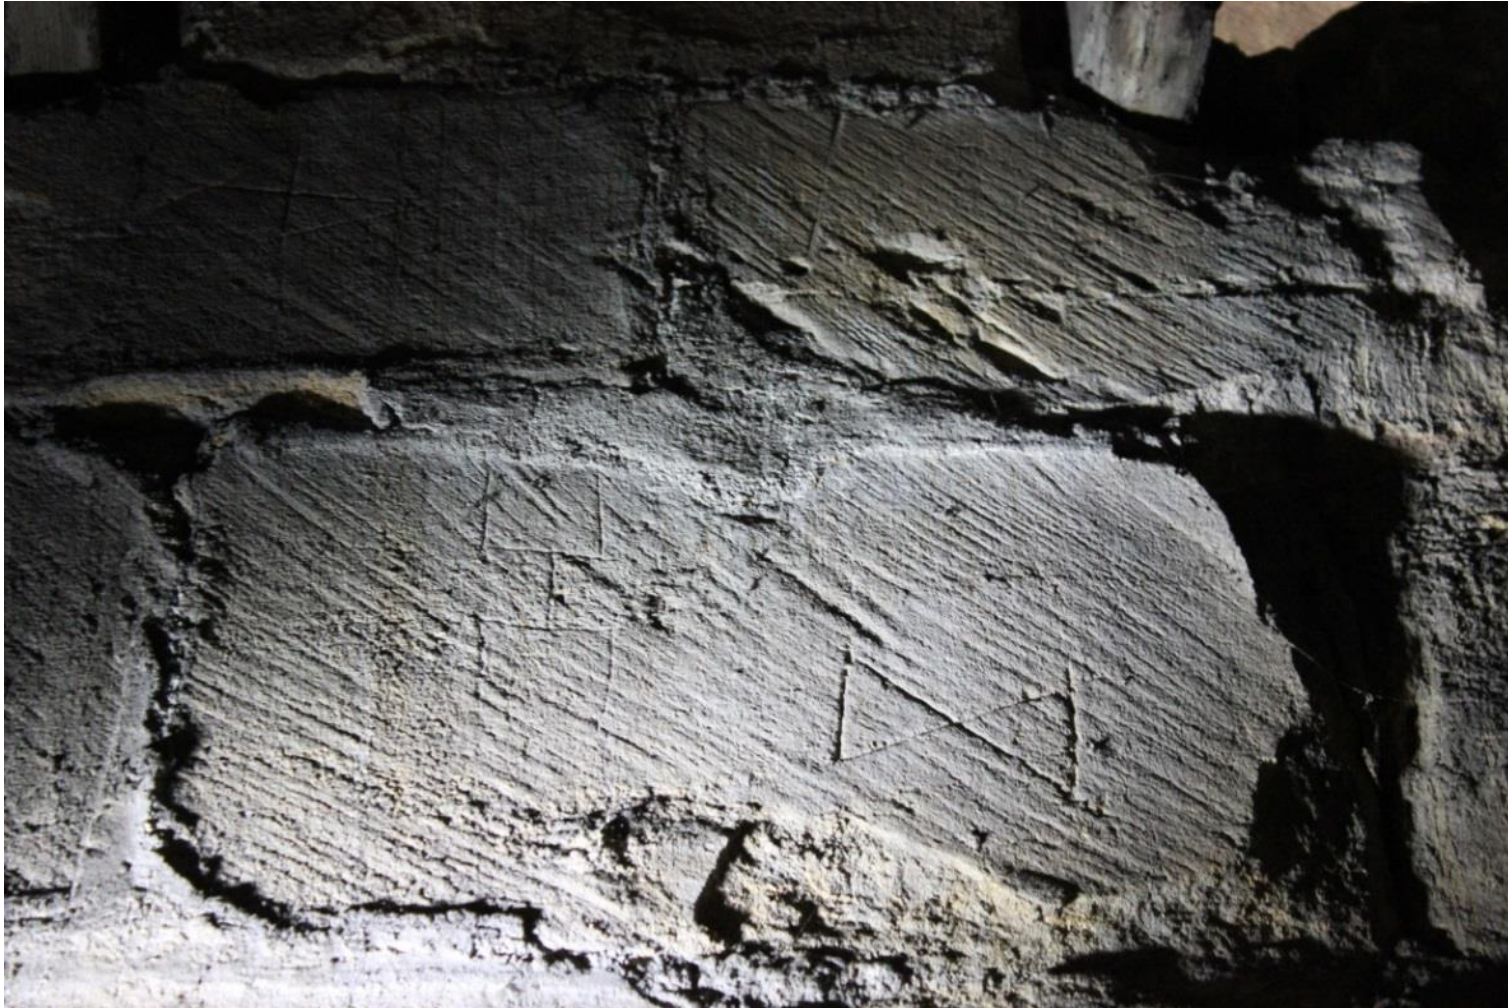
Mason 12 – Mark 69

This stone below not only shows his mark but gives building instructions as to how the stones were to be laid.

However, given that Mason 12 also cut his mark on a block, which also contained building instructions as to how blocks were to be joined (Mark record 69), this could indicate he had some importance on site and was perhaps the master mason, or at least one of the more prominent masons to be working here.

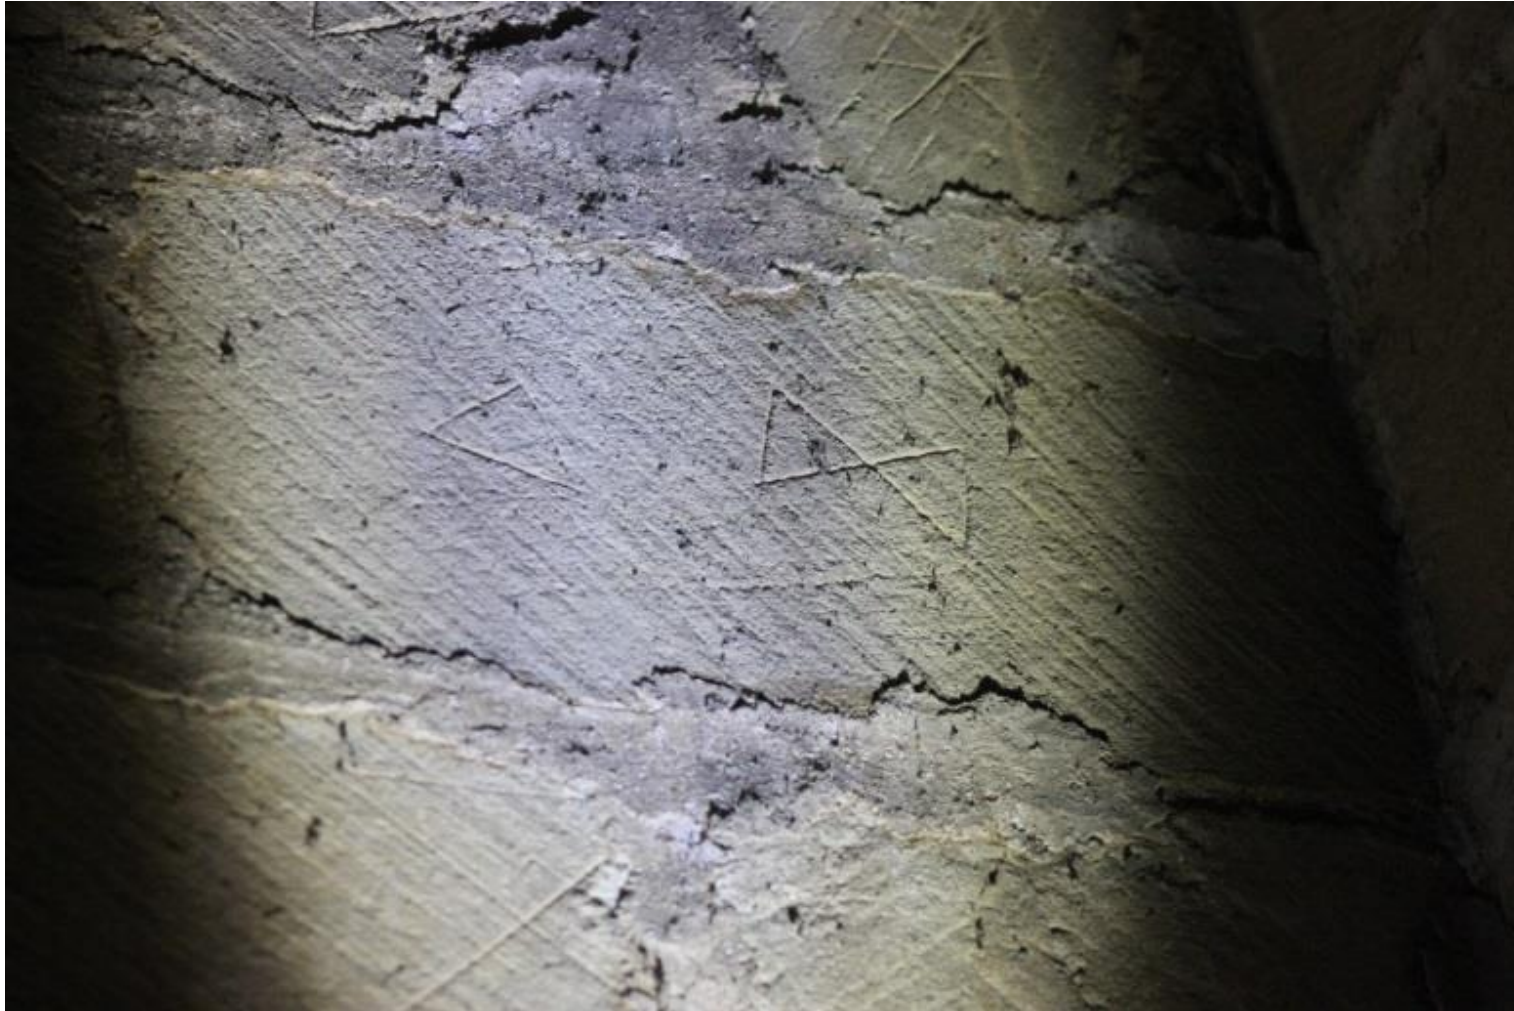
Mason 3 Mark 427 and Mason 12 – Mark 428

He also appears to approve Mason 3's cutting of his block as both marks are on the same stone.

There is also another indication regarding his importance, which comes in the form of his mark on a block which also had another mason's mark on it. This refers to the block containing mark records 427 & 428. Here Mason 3 also appears along with Mason 12. As suggested above, this could well mean that Mason 12 was approving the work of Mason 3, who had perhaps been his former apprentice but who had recently finished his apprenticeship and was now a full mason with his own mark. Perhaps there were regulations which required checks to be made on those who had recently joined the ranks of full masons. There is certainly a slight link in that Mason 3 chose half of the mark belonging to Mason 12 as his own mark, a single triangle which is half of the double adjoining triangles of Mason 12.

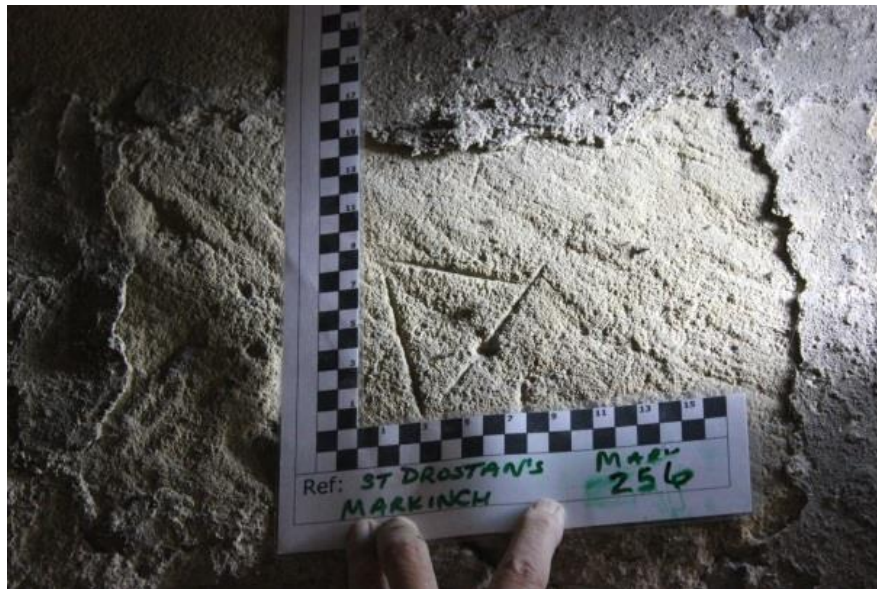
Mason 3 – Mark 256

A triangle was the mark chosen by this mason, although it varied greatly from a small neat triangle to a more uneven sided one. He worked on most floors apart from the 4th floor and the outer face of the tower within the loft. 37 of his marks were noted. It is just possible that Mason 3 had been an apprentice of Mason 12 and when gaining his mark at the end of his training he took the triangle as his mark, which is a half of the mark of his former master. This may explain why both marks are on the one stone.

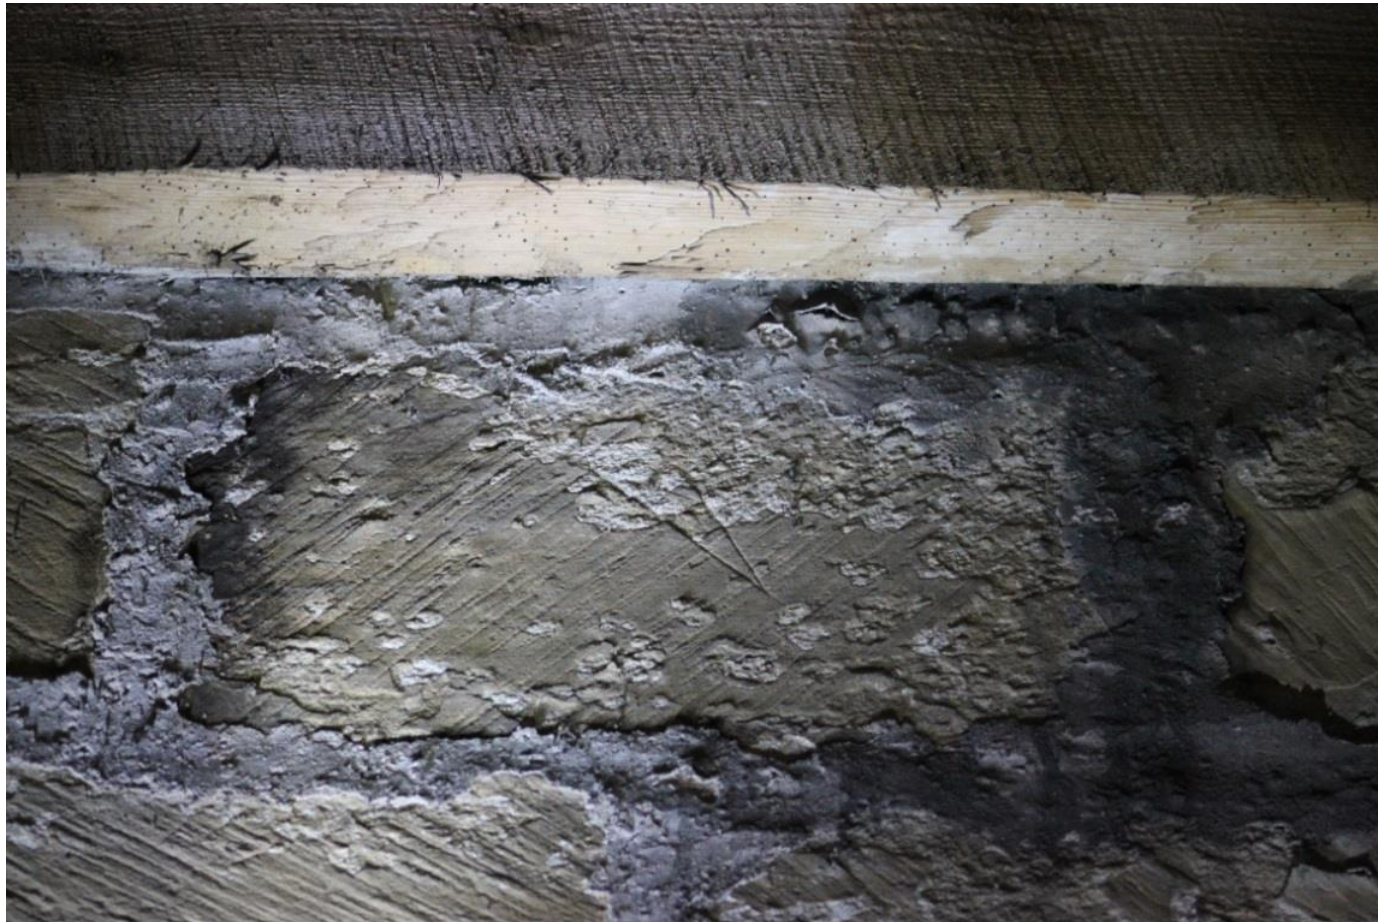
Mason 9 –Mark 635 or Mason 3?

It is possible that this may be a misinterpretation of Mason 3 but it appears to be a V so may be a different mason, but due to the height it was not possible to look at it more clearly. Only one instance on the 2nd floor was recorded of this mark.

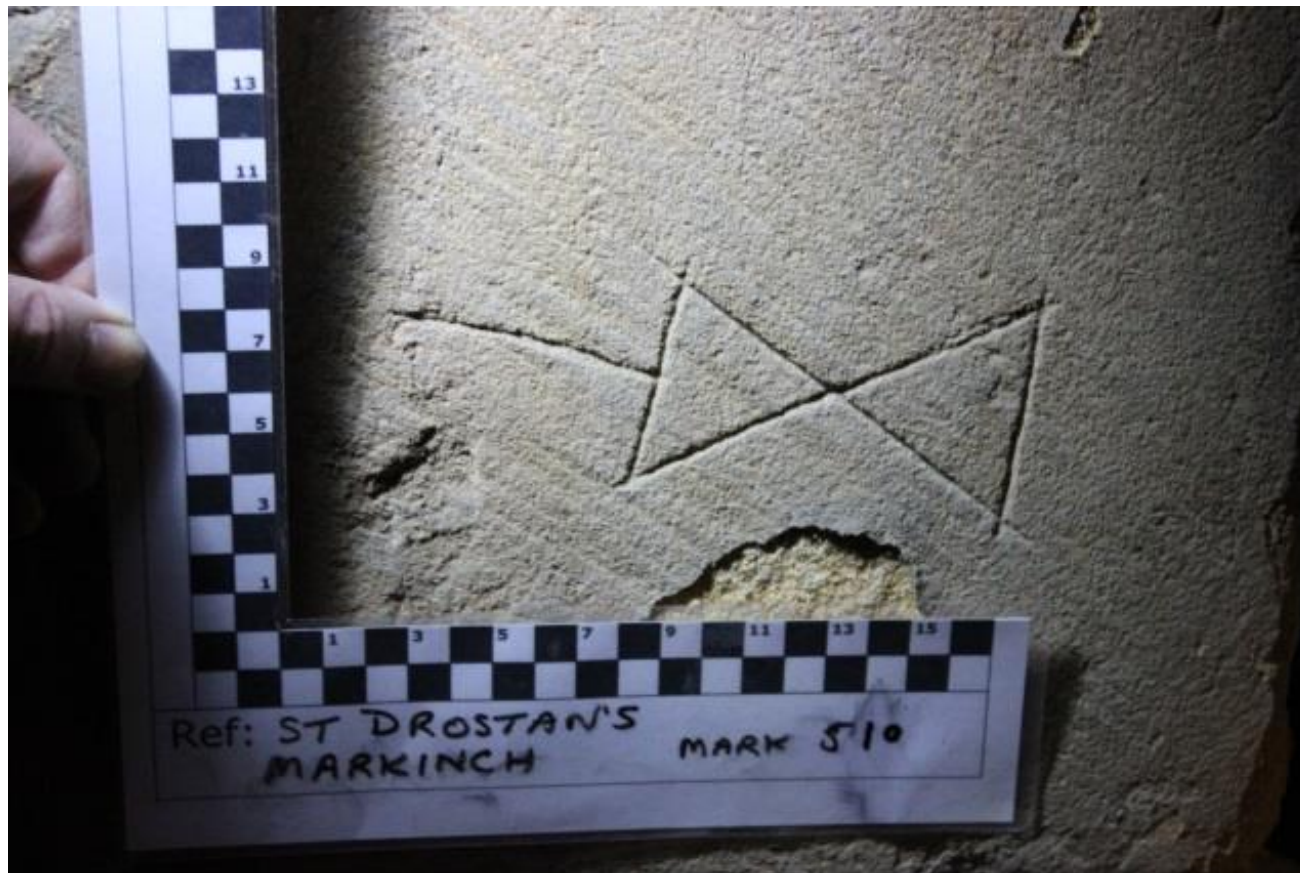
Mason 26 – Mark 510

Very similar to Mason 12's mark but with an added line extension to one end formed this mason's mark. Only one example was found inside the loft on the outer wall of the tower. It may either be accidental and is Mason 12 or perhaps a son working with his father?

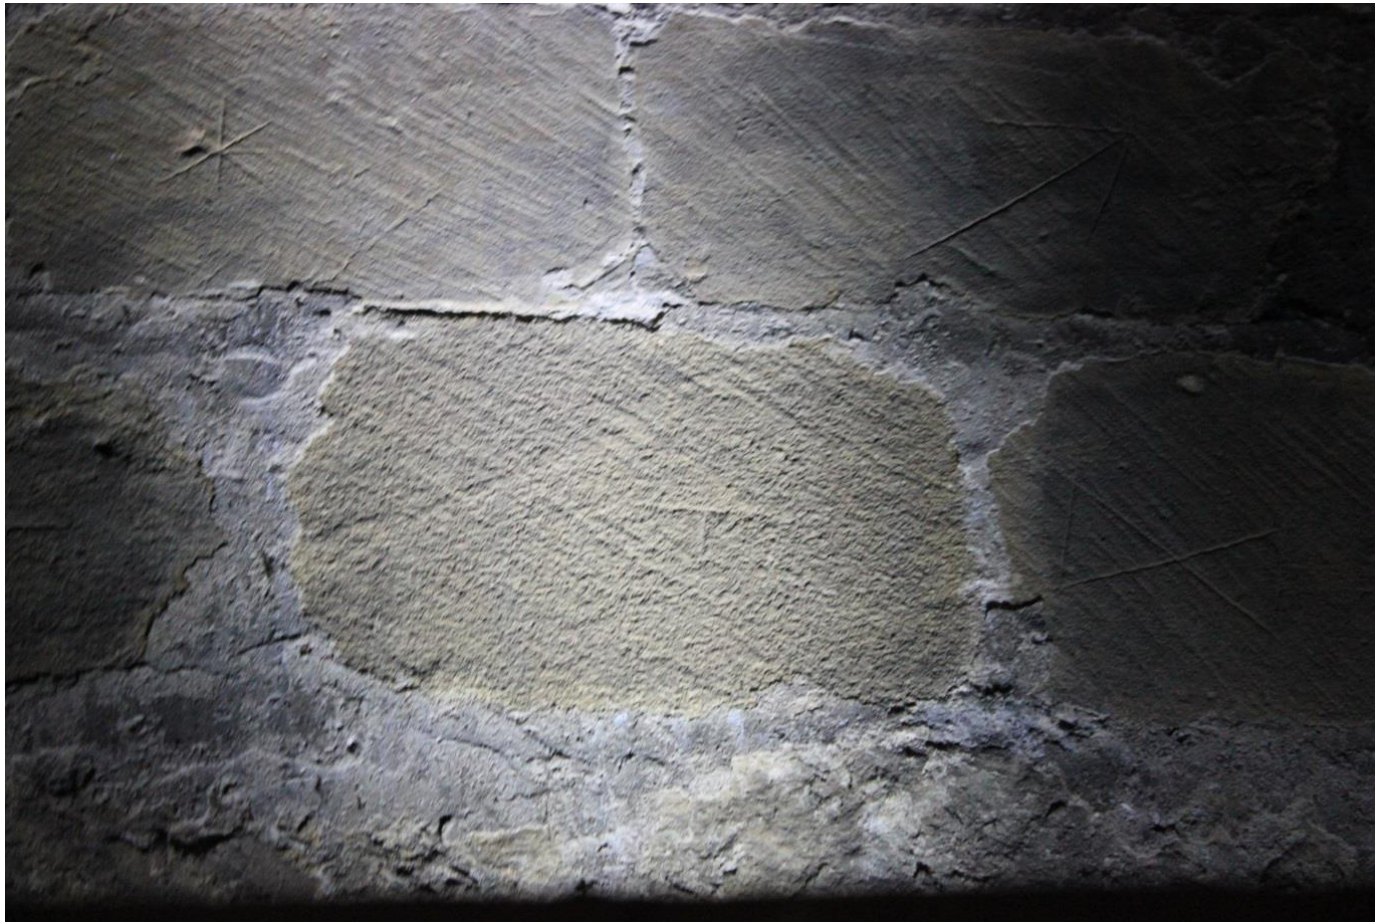
Mason 14- Mark 665

Only one example of this mark was noted and may not be a separate mason, but it doesn't appear to fit in with any other grouping particularly, apart from possibly Mason 1. This mark was only found on the 2nd floor.

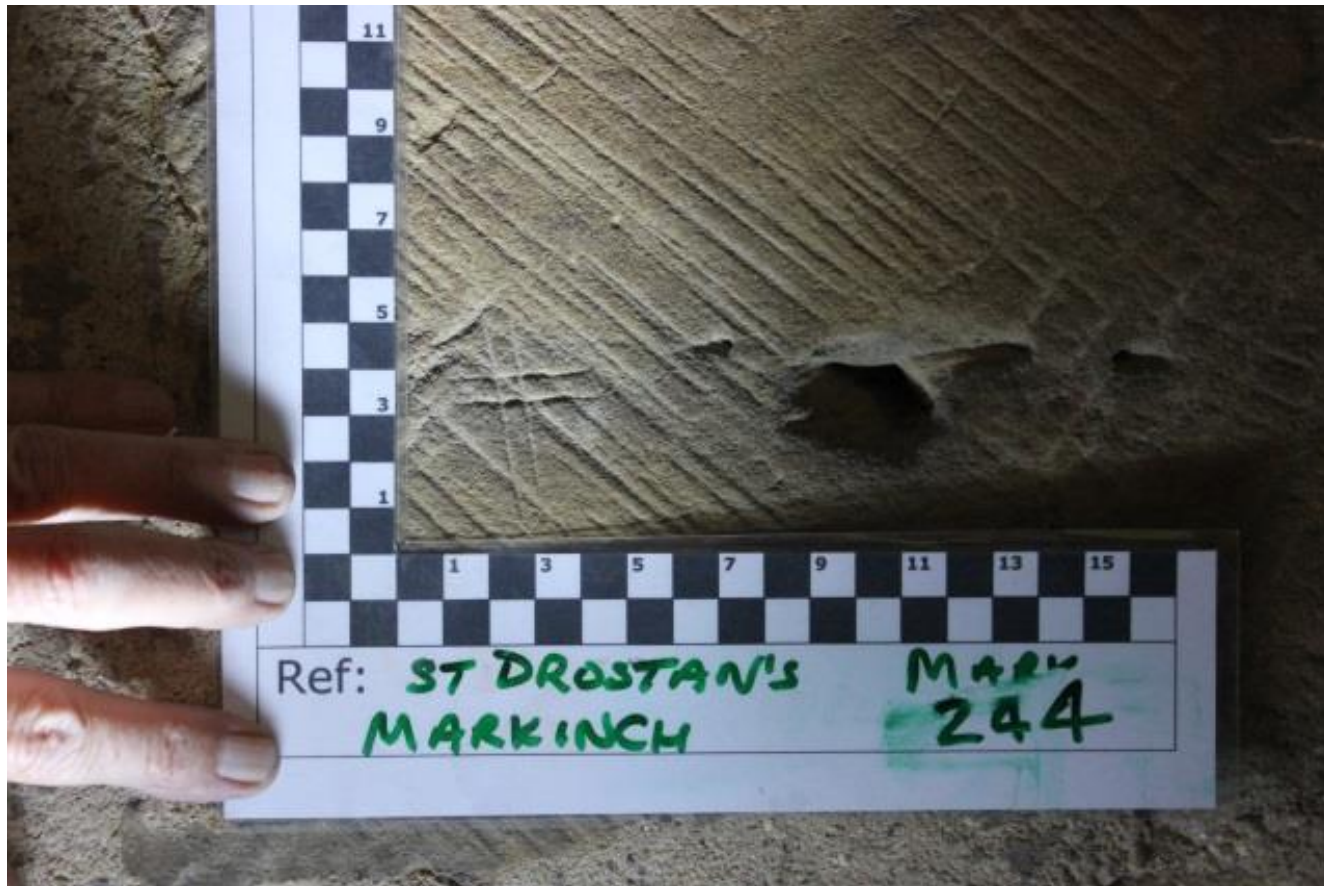
Mason 17 – Mark 244

Only one mark from Mason 17 was recorded on the 1st floor only. A hashtag mark with nothing noted similar elsewhere.
