ST DROSTAN'S CHURCH, MARKINCH, FIFE

A Survey of Masons' Marks within the Tower

July 2015

Moira Greig

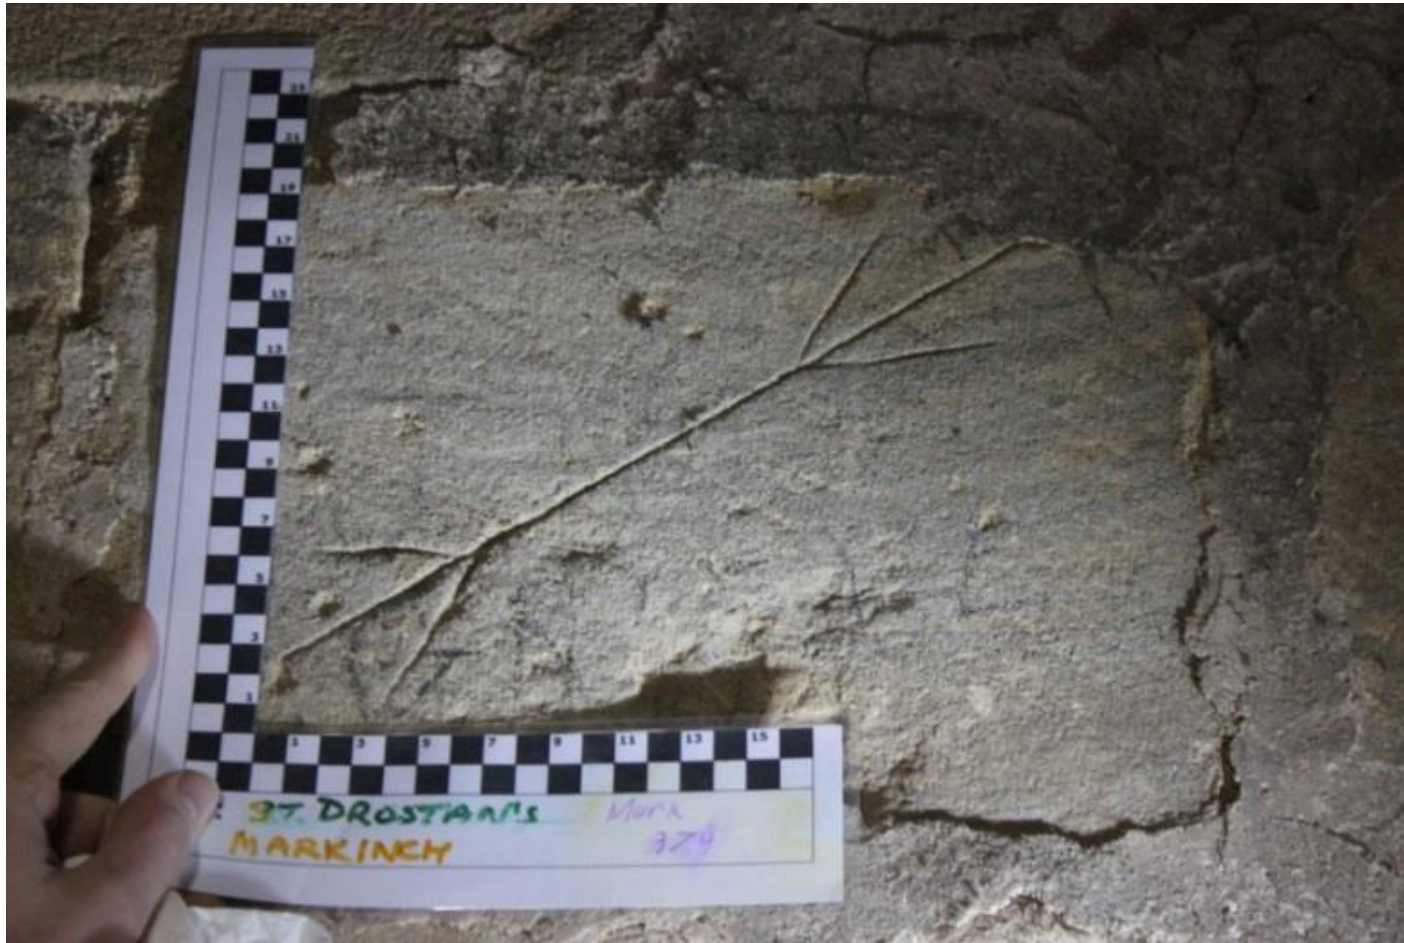
Mason 18 – Mark 374

A very distinct mark found only on the 1st, 2nd and 4th floors. Very long and narrow based on two arrowheads pointing towards each other. 9 examples of this mark were noted.

The one mark which is more unique and likely to be of more use for dating is the elongated double arrow of Mason 18, which to date the writer has not come across in over 70 buildings where marks have been recorded.

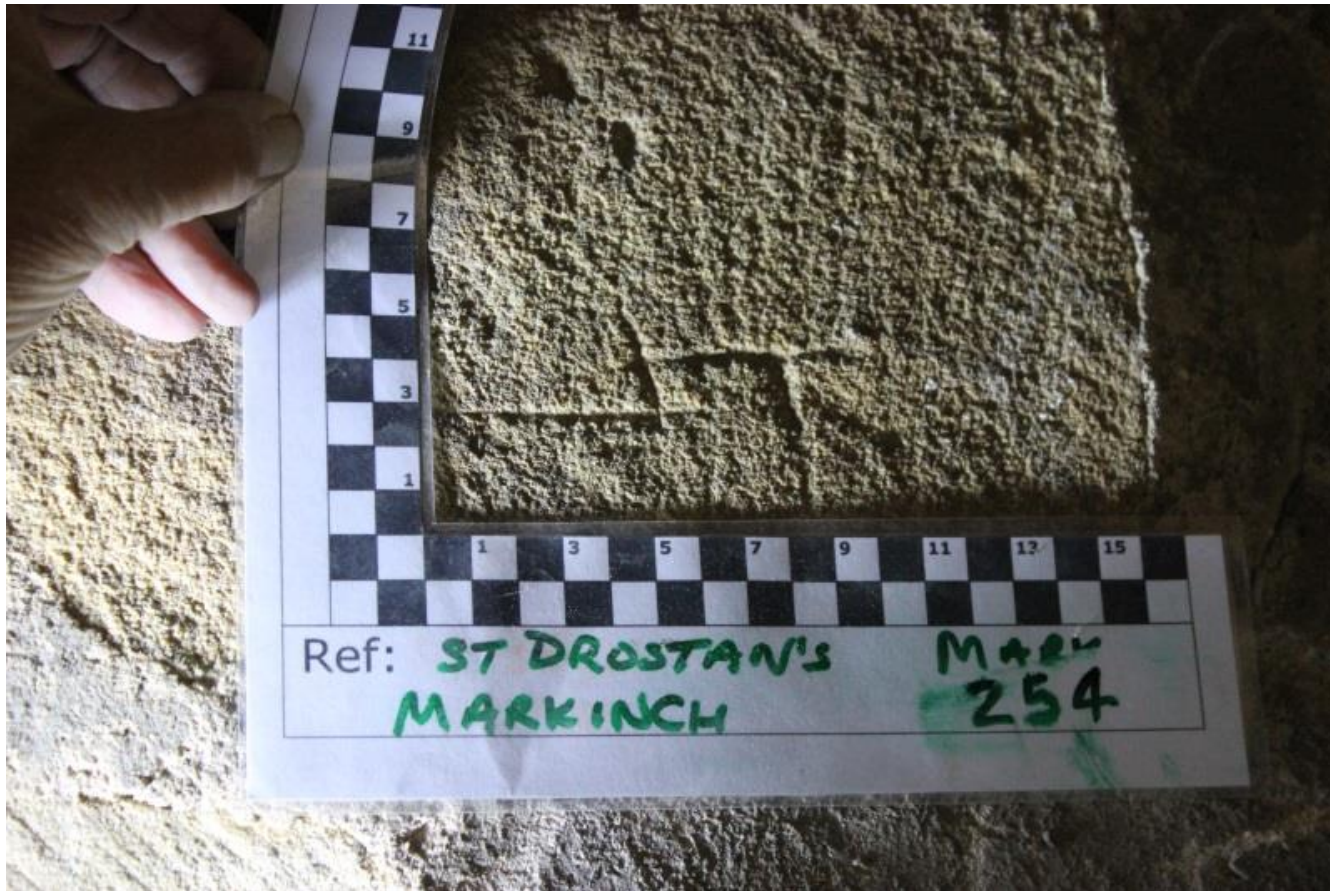
Mason 19 – Mark 254

Only a single mark recorded of possible inverted initials T T. Only found on the 1st floor.

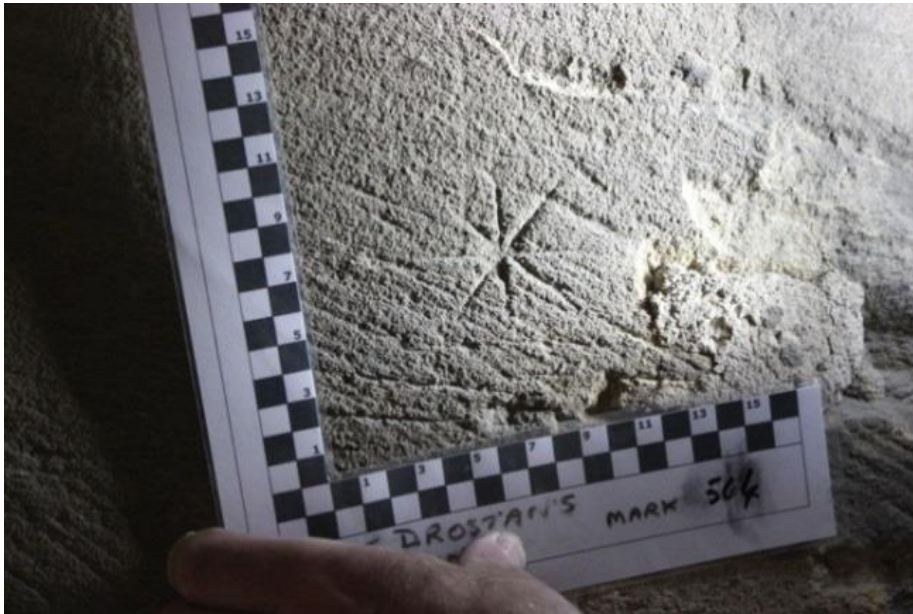
Mason 20 – Mark 564

This mason used an asterisk for his mark. Some are quite small while others much larger, which again could indicate that others cut the mark for him. This mason worked on 1st floor, 2nd floor, 3rd floor, 4th floor and on the stairs. 48 of his marks were recorded.

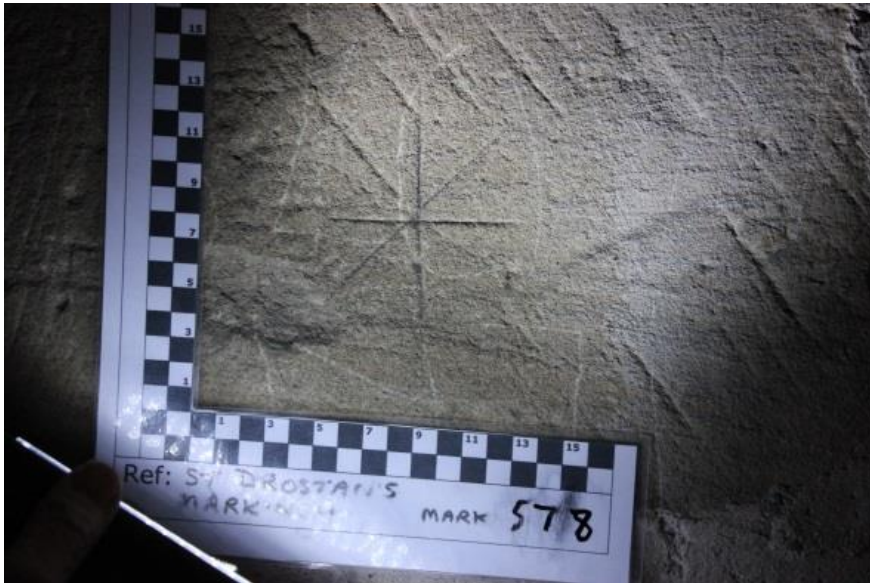
Mason 20 – Mark 578

The two examples below show the same mark but on a larger scale.

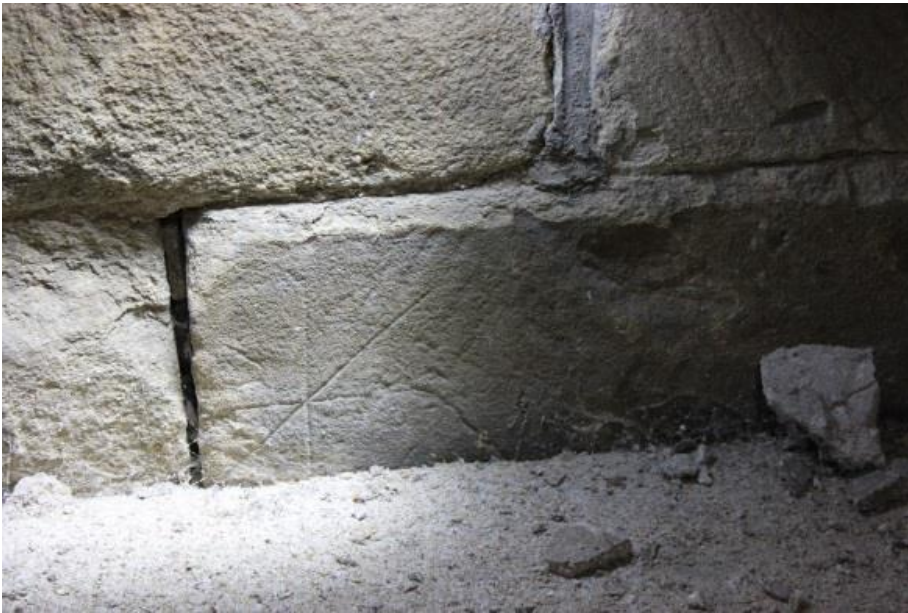
Mason 28 - Mark 772

This mason uses a very similar mark to the above Mason 20 but with one less line. He worked on the 3rd and 4th floors, with only 4 examples of his work recorded.

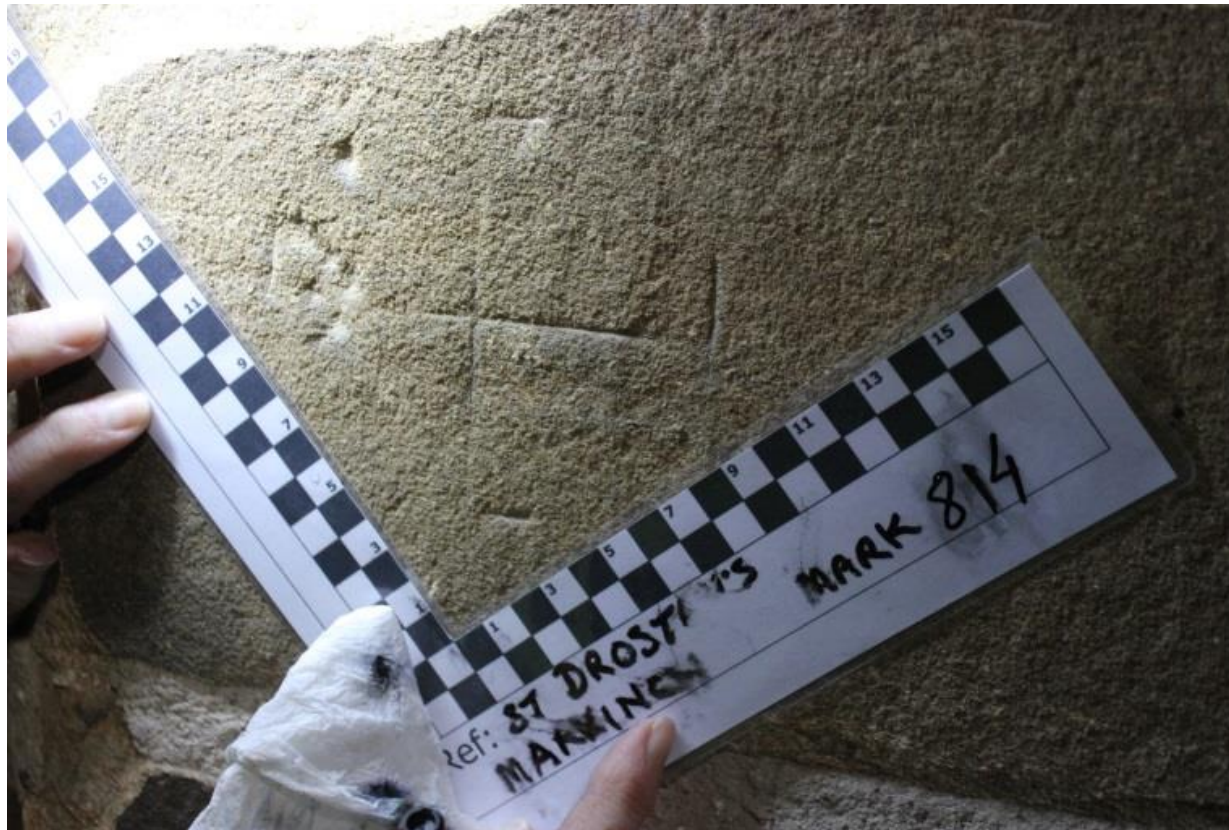
Mason 21 – Mark 814

The marks of these two masons 21 & 22 are again similar but each in reverse, which could again signify a family working together. Both marks are only found on the spiral stair. Mason 27 is also very similar in design, who is perhaps of the same family or yard.

4 examples were found of Mason 21 and 3 examples of Mason 22. Only one was found of Mason 27.

What is of interest is that Masons 21 & 22 appears to have been brought in to work only on the spiral stair. This may be because they were more skilled in cutting blocks on a curve than some of the other masons, who generally only cut ashlar blocks.

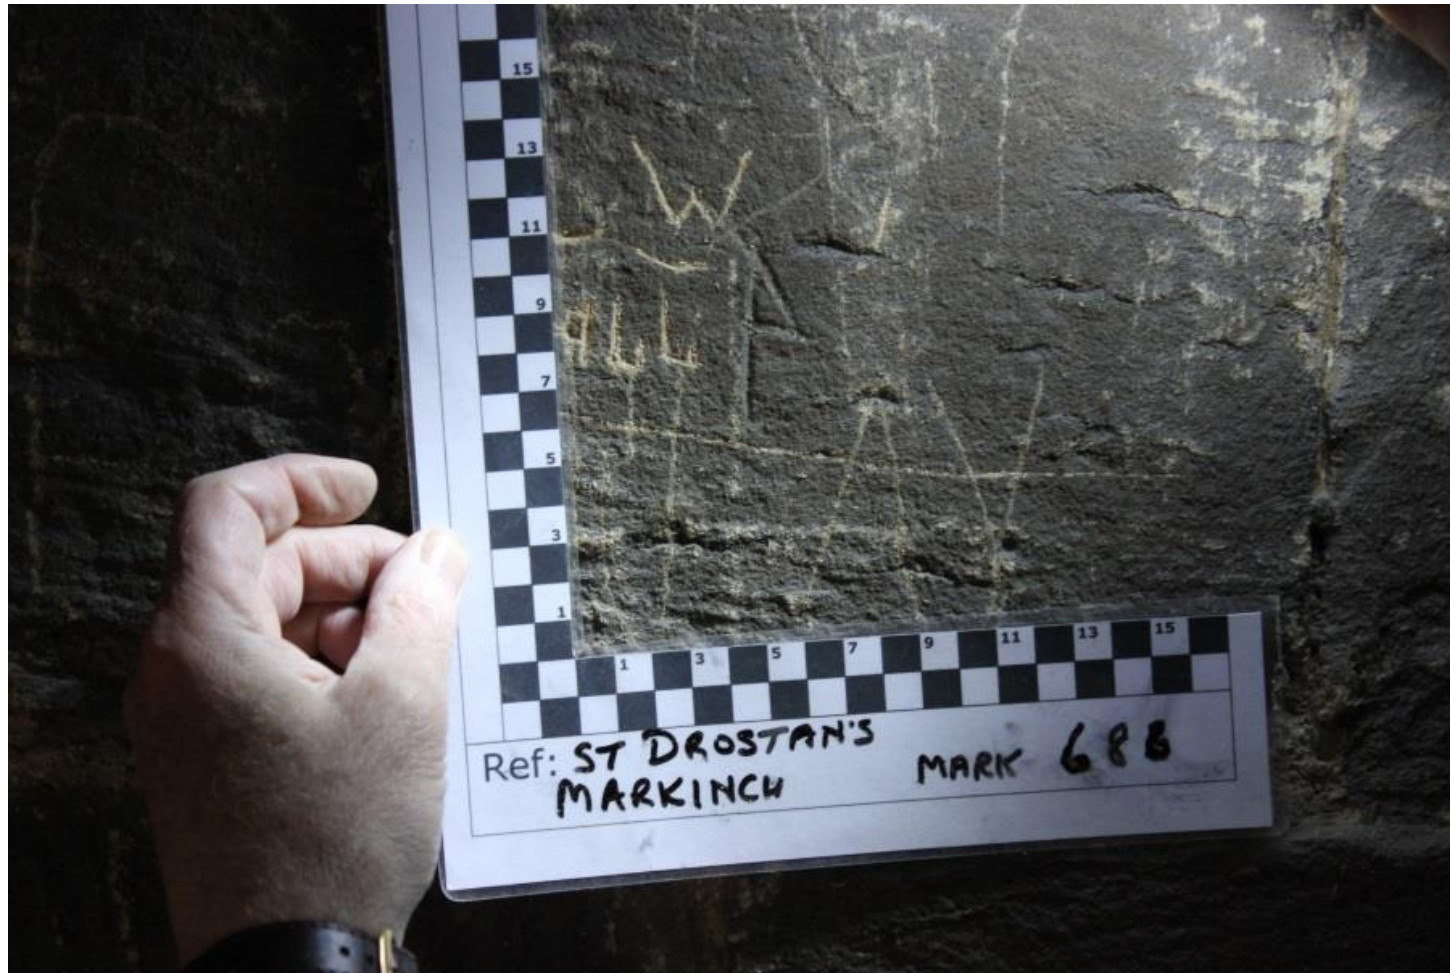
Mason 23 – Mark 686

Only one example of Mason 23 was recorded on the 3rd floor. It is a small sharply cut distinct mark.

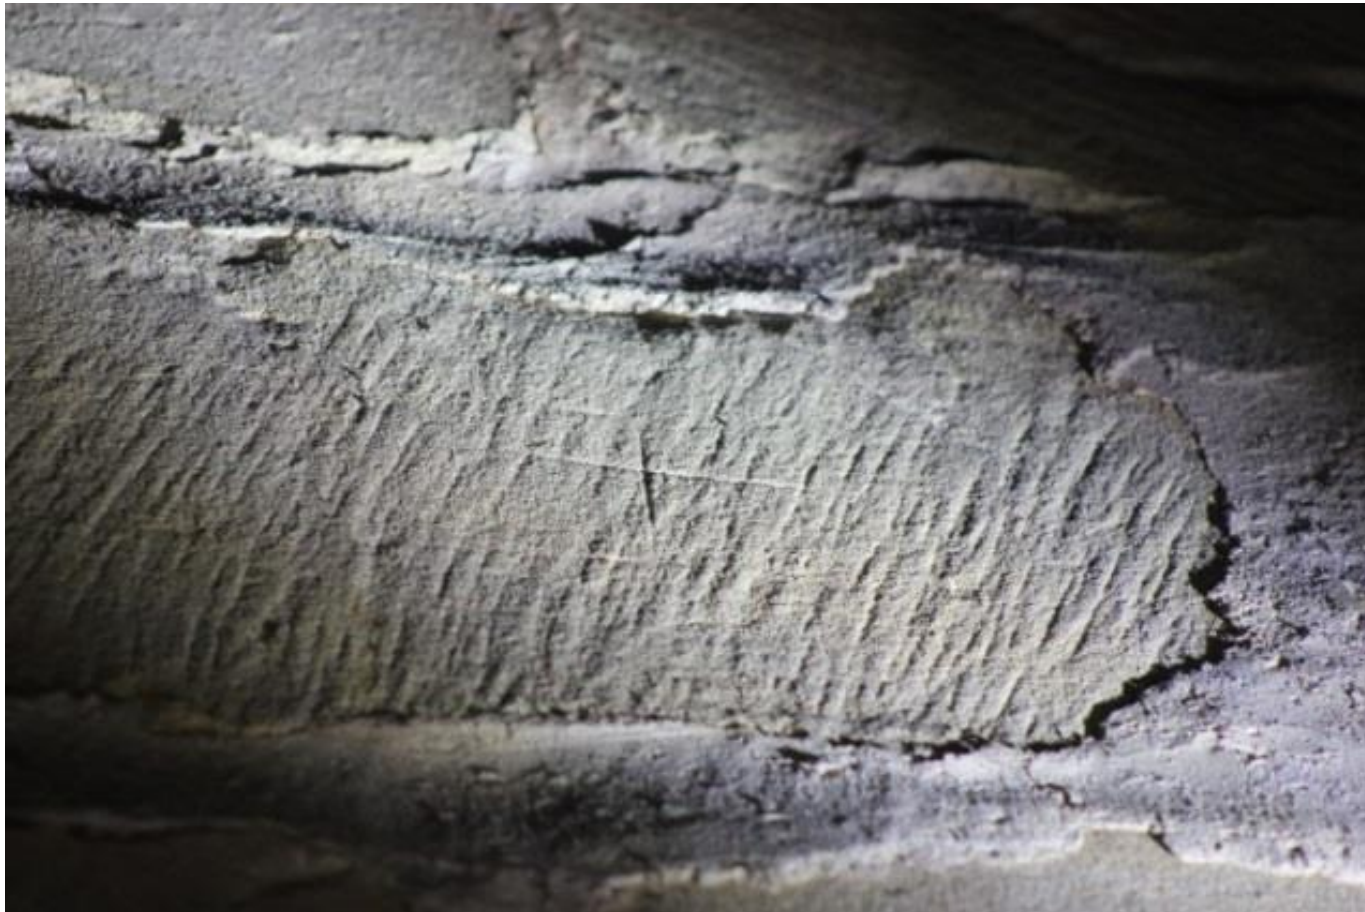
Mason 24 – Mark 358

This mason's mark is like a trident but unfortunately the examples are poor and faint. He worked on the 1st floor only with only 2 examples visible.

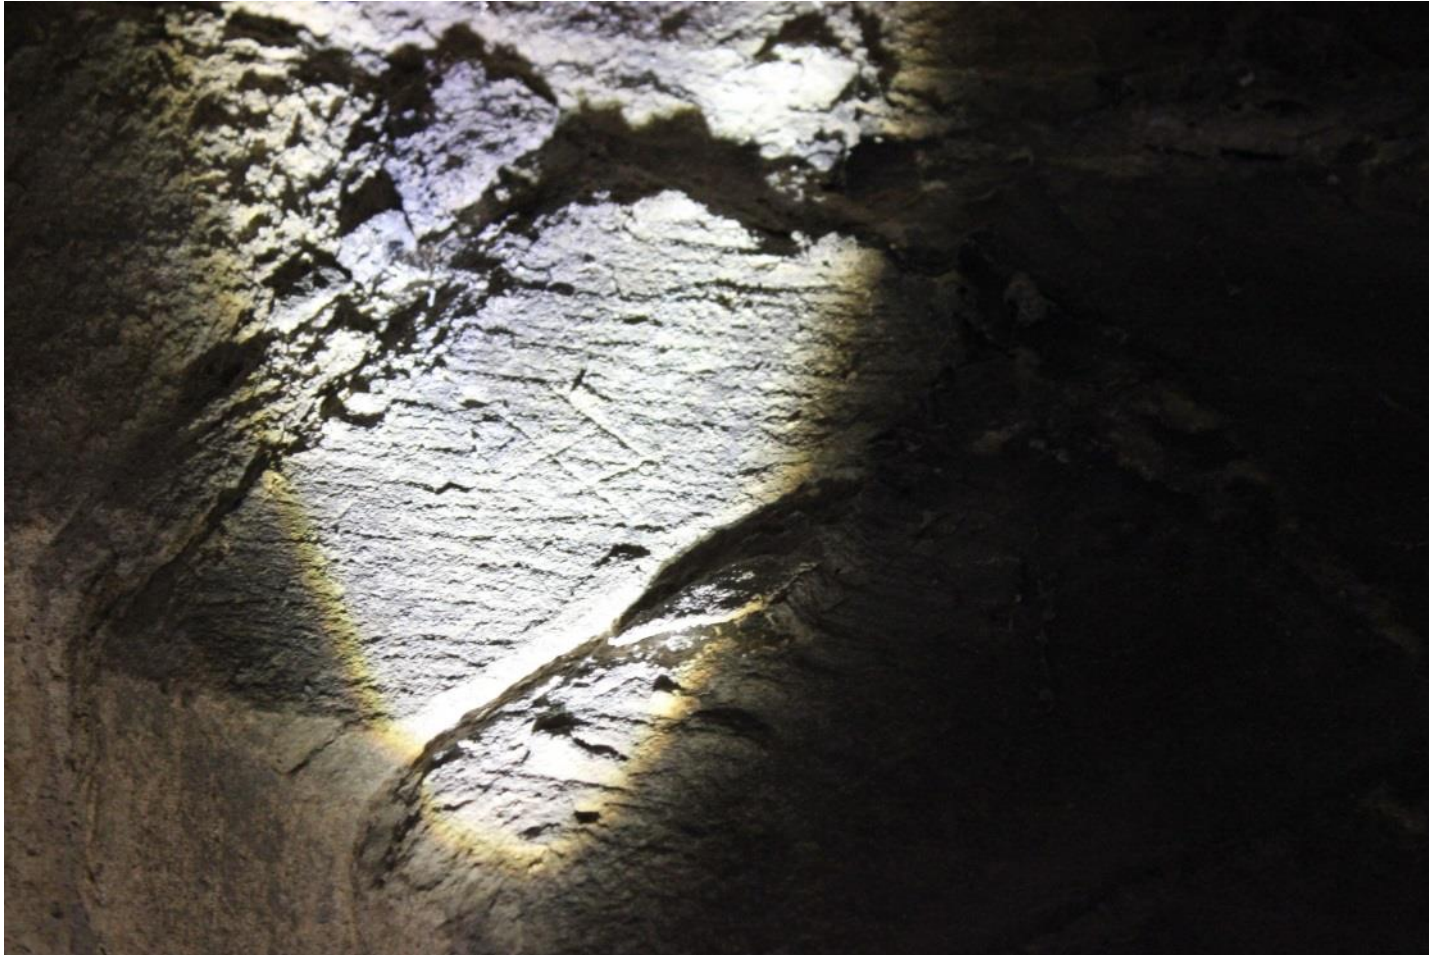
Mason 31 – Mark 703

Mason 31 was only found on the 3rd floor where 2 examples of his mark were recorded.
